THE RE-SEALING OF JOINTS IN CAST IRON GUTTERS

MGMA DISCLAIMER

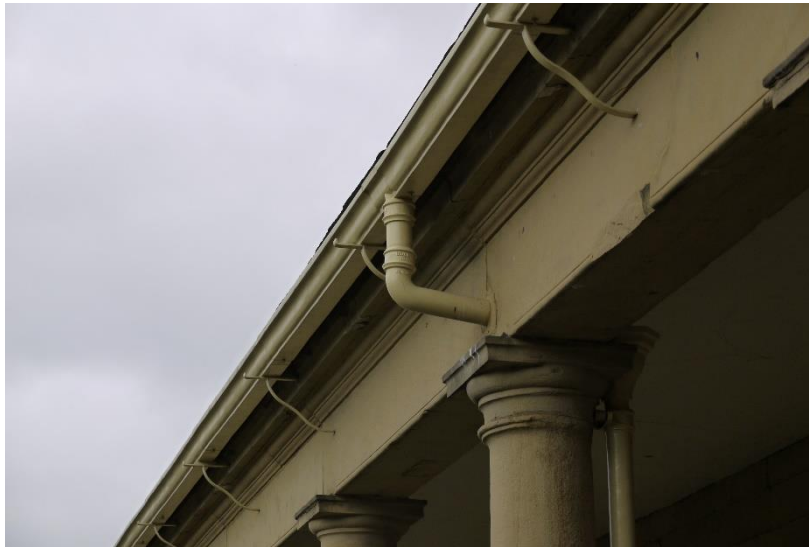
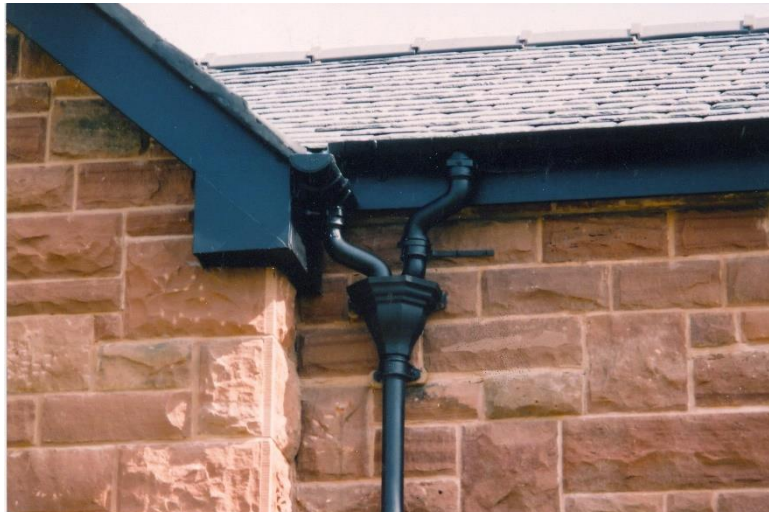
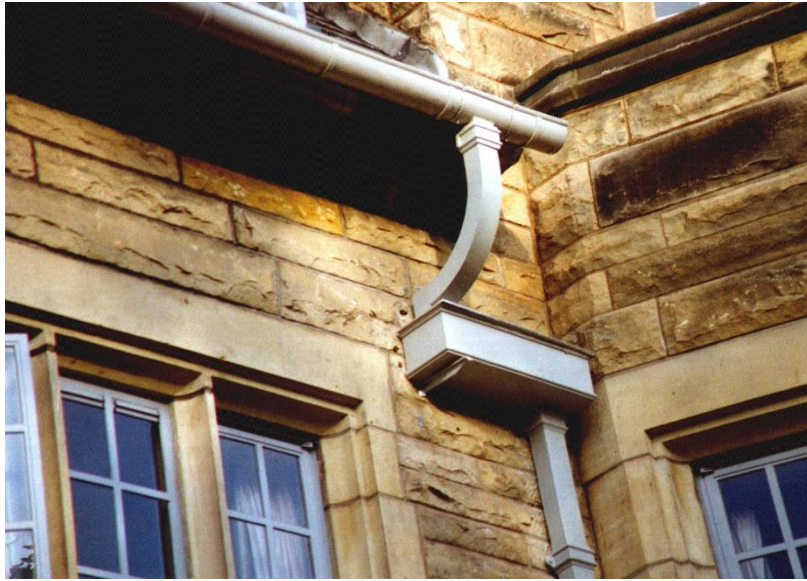
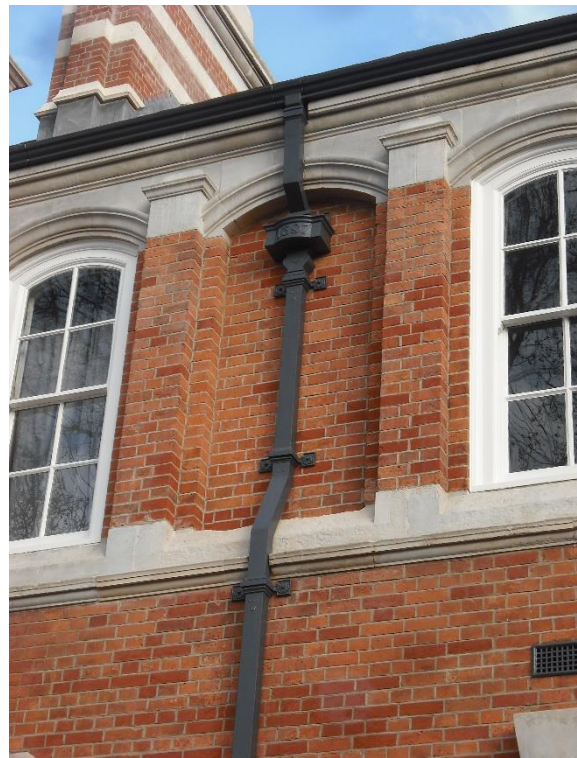
Typical examples of re-sealed joints

Leaking joints on gutter installations are normally due to a breakdown of the old putty compound. This jointing method was historically used however due to ageing, the putty hardens and cracks causing 'dripping joints'. The joints can be successfully re-sealed by following the recommendations below.

- To effectively re-seal joints in cast iron gutters necessitates the removal of jointing bolts and separating the sections of gutter before any successful remedial work.

- A short-term repair may be effected by thoroughly and vigorously wire brushing the internal gutter surfaces to ensure removal of loose debris and any flakey rust. The cleaned surface of joint area may then have an application of black rubberised gutter sealant or low modulus silicone sealant applied thoroughly to the joint area providing it is thoroughly dry.

- In summary, for leaking gutter joints it is **strongly** recommended to cut through the jointing bolts, thoroughly cleaning the gutter and reseal with a modern low modulus silicone sealant which will ensure many years of trouble-free life.
