THE RE-SEALING OF JOINTS IN CAST IRON GUTTERS

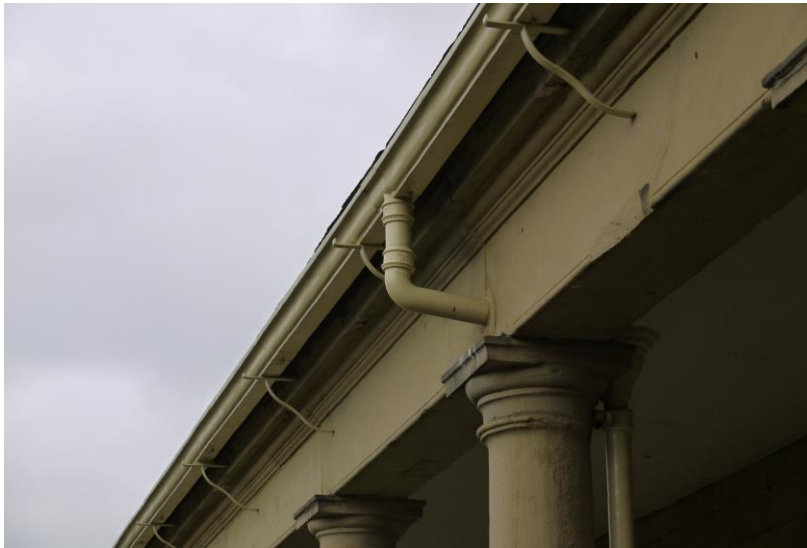
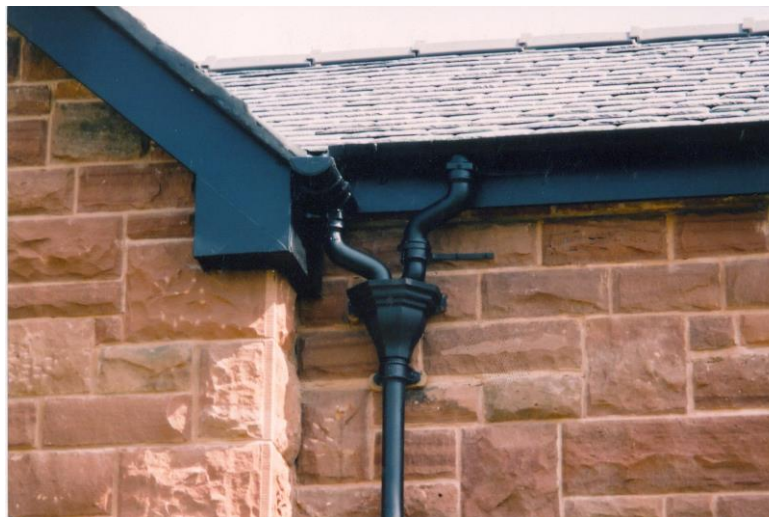
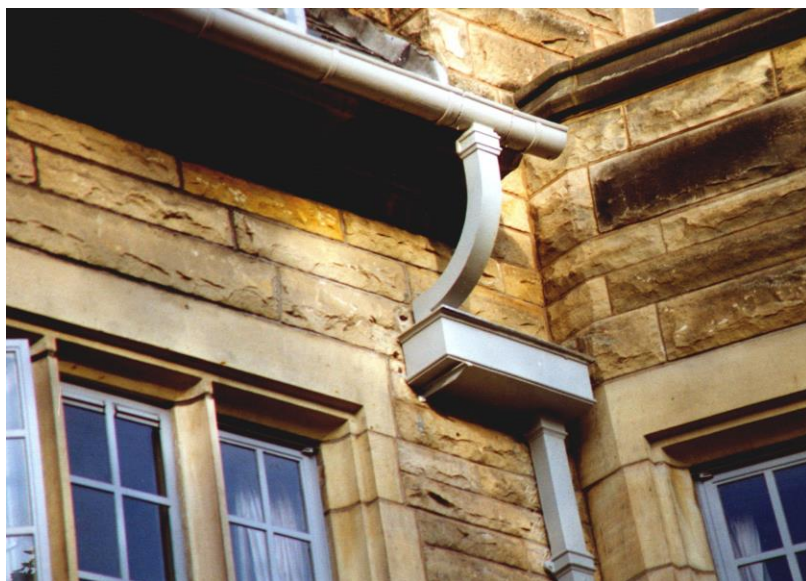
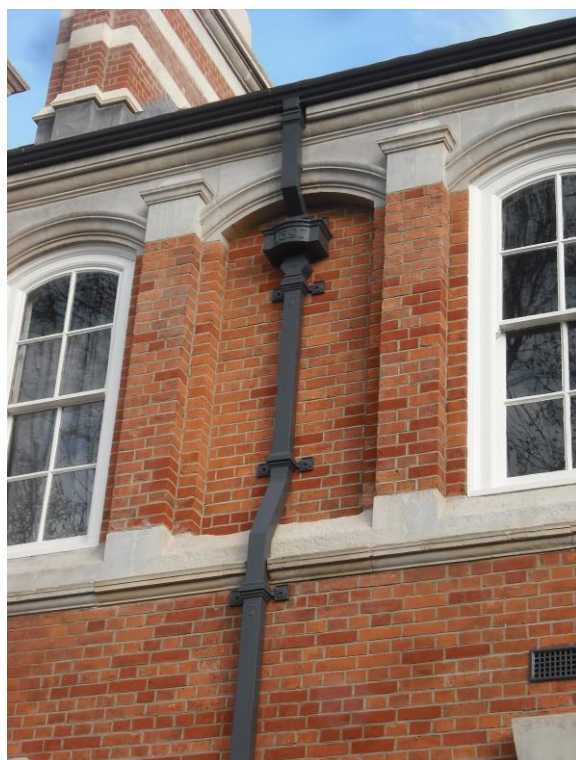
Typical examples of re-sealed joints

- In summary, for leaking gutter joints it is **strongly** recommended to cut through the jointing bolts, thoroughly cleaning the gutter and reseal with a modern low modulus silicone sealant which will ensure many years of trouble free life.
