## REFURBISHMENT OF INTERNAL METAL GUTTERS

### INTRODUCTION

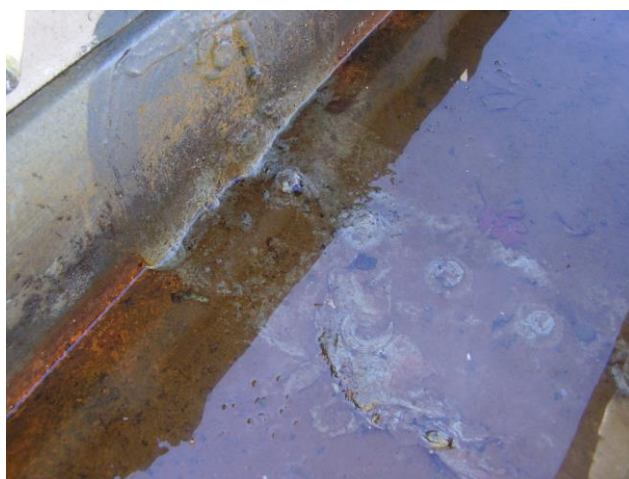
*Fig 1 Metal gutter suffering corrosion and joint leakage*

In most industrial buildings with internal gutters, those gutters are fabricated from galvanised steel with bolted joints. However, all building products have a life expectancy and in older installations, corrosion of the gutter steel substrate and leakage at the bolted gutter joints can occur.

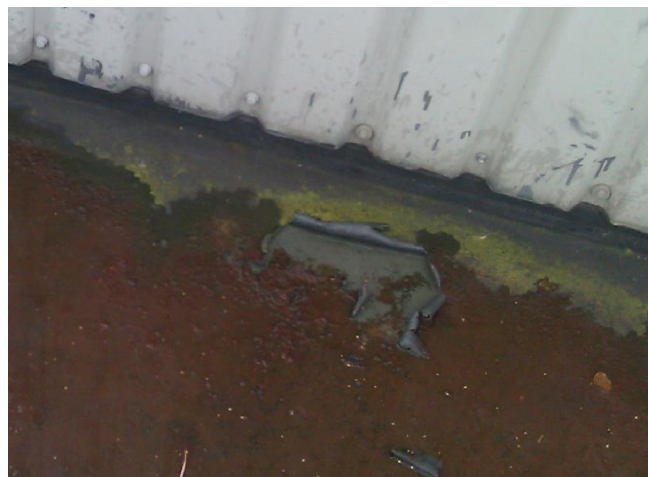
*Fig 2 Liquid applied lining material delaminating from the gutter*

The gutter has to be completely clean, grease and debris free, so that the compound can adhere well to the gutter. Great care must be taken when applying the material around bolt heads to avoid pin prick holes, through which water can leak. Badly applied sealant of this type can peel off after a fairly short period of time, leading to a renewal of leakage into the building. In most cases this is not considered a permanent repair.

A more sophisticated approach is to line the gutter with a liquid applied sealant together with a separate fibre reinforcement mat. Usually this will involve multiple layers of reinforcement and sealant, and will often be applied as a total lining rather than locally across joints. This approach can be very successful, though again it must be noted that preparation, workmanship, and weather conditions during installation can have a significant impact on the effectiveness of the final product. Care must be taken to ensure that the surfaces are clean and dry before the lining takes place, and that outlets are protected against sealant running into them and fouling the rainwater pipes.

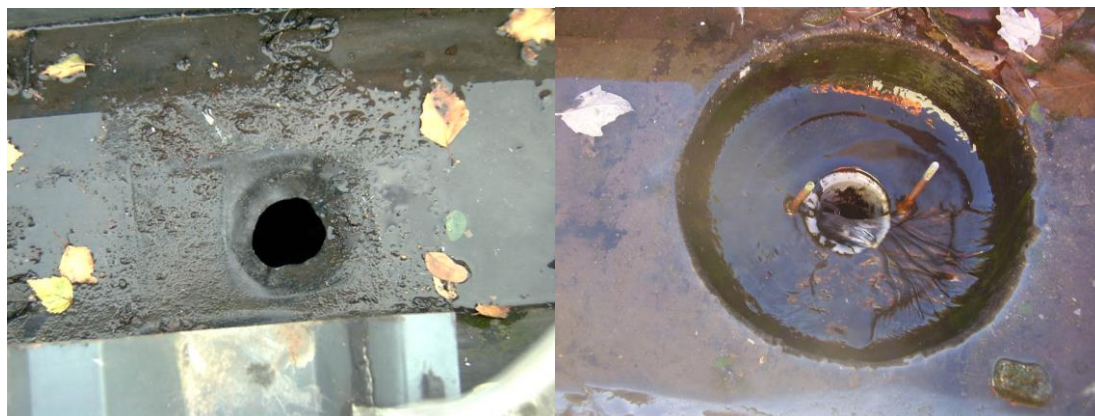
*Fig 3 Gravity (left) and siphonic (right) outlets restricted by installed liners*

Installing sleeve outlets in any lining system reduces the capacity of the system, as the new outlets will be smaller. This may lead to a situation where day to day leaks are prevented at the expense of significant overflows in heavy rain. Gutters must be checked to ensure that their design capacity after the installation of the liner is adequate; if not, additional outlets may have to be added to achieve this. It is likely that the installer of the liner would be held liable for any flood damage which occurred after installation, so this needs to be checked.

One area where this is particularly important is where the building has siphonic outlets. Any liner which protrudes down into a siphonic outlet should not be used without taking advice from the original manufacturer of the siphonic system or an independent expert. Lining into siphonic outlets can reduce capacity by as much as 80 per cent which can have a disastrous effect of the ability of the roof to drain.

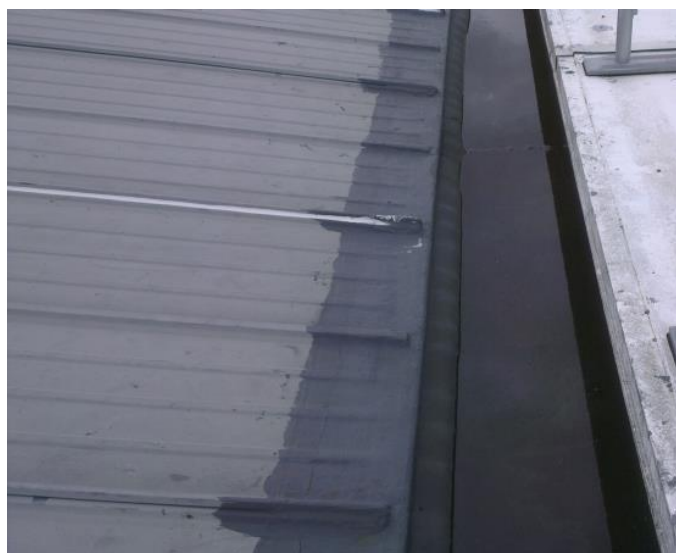
*Fig 4 Water trapped below side slope of lining system extended onto roof sheets*

Sometimes lining systems, either liquid-applied or membrane, are dressed up to the underside of, or even onto, the roof sheets to increase the effective gutter depth. This can be a dangerous method to adopt, as if there are any faults at all in the roof sheets, water will flow down the liner tray, build up in the void between the new liner and the existing gutter liner, and thus leak into the building.
