REFURBISHMENT OF INTERNAL METAL GUTTERS

INTRODUCTION

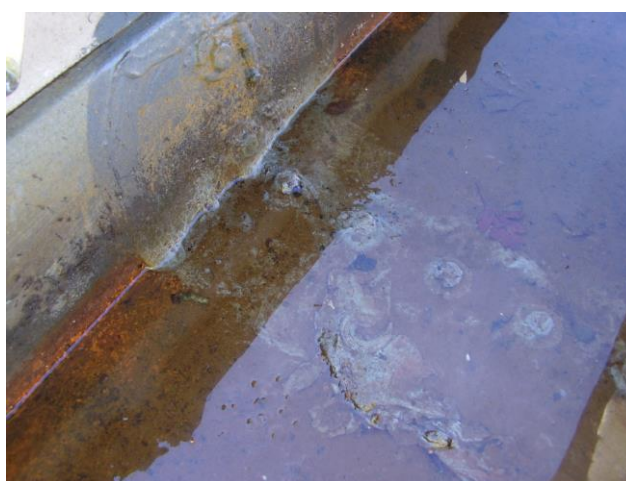
Fig 1 Metal gutter suffering corrosion and joint leakage

In most industrial buildings with internal gutters, those gutters are fabricated from galvanised steel with bolted joints. However, all building products have a life expectancy and in older installations, corrosion of the gutter steel substrate and leakage at the bolted gutter joints can occur.

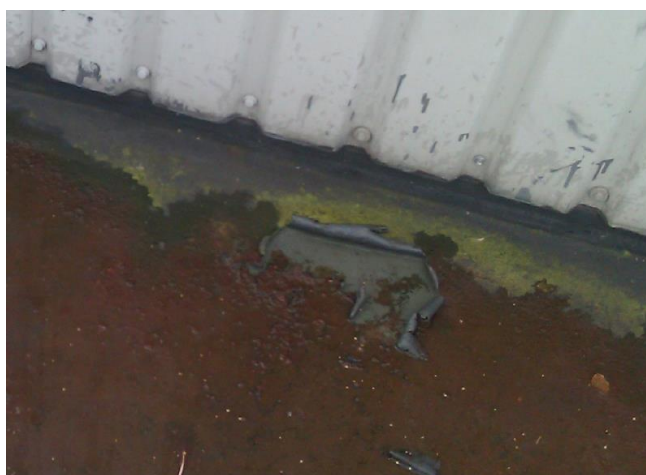
Fig 2 Liquid applied lining material delaminating from the gutter

A more sophisticated approach is to line the gutter with a liquid applied sealant together with a separate fibre reinforcement mat. Usually this will involve multiple layers of reinforcement and sealant, and will often be applied as a total lining rather than locally across joints. This approach can be very successful, though again it must be noted that preparation, workmanship, and weather conditions during installation can have a significant impact on the effectiveness of the final product. Care must be taken to ensure that the surfaces are clean and dry before the lining takes place, and that outlets are protected against sealant running into them and fouling the rainwater pipes.

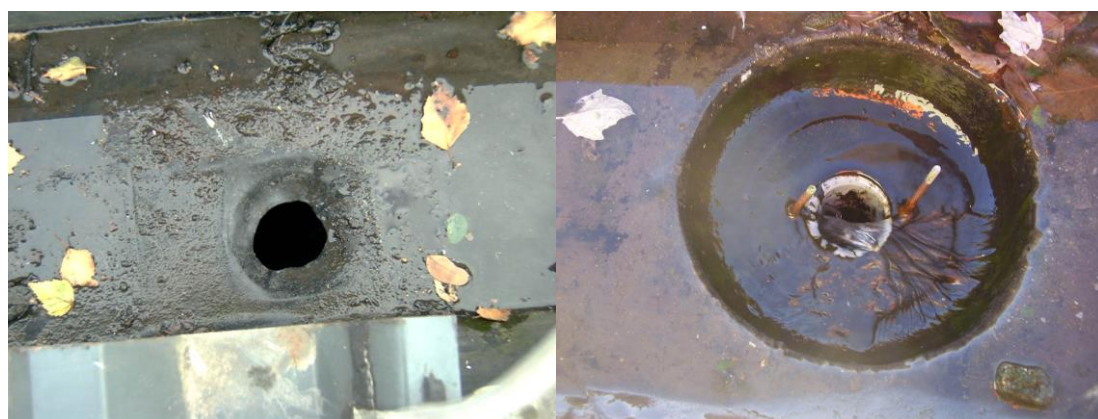
Fig 3 Gravity (left) and siphonic (right) outlets restricted by installed liners

Installing sleeve outlets in any lining system reduces the capacity of the system, as the new outlets will be smaller. This may lead to a situation where day to day leaks are prevented at the expense of significant overflows in heavy rain. Gutters must be checked to ensure that their design capacity after the installation of the liner is adequate; if not, additional outlets may have to be added to achieve this. It is likely that the installer of the liner would be held liable for any flood damage which occurred after installation, so this needs to be checked.

One area where this is particularly important is where the building has siphonic outlets. Any liner which protrudes down into a siphonic outlet should not be used without taking advice from the original manufacturer of the siphonic system or an independent expert. Lining into siphonic outlets can reduce capacity by as much as 80 per cent which can have a disastrous effect of the ability of the roof to drain.

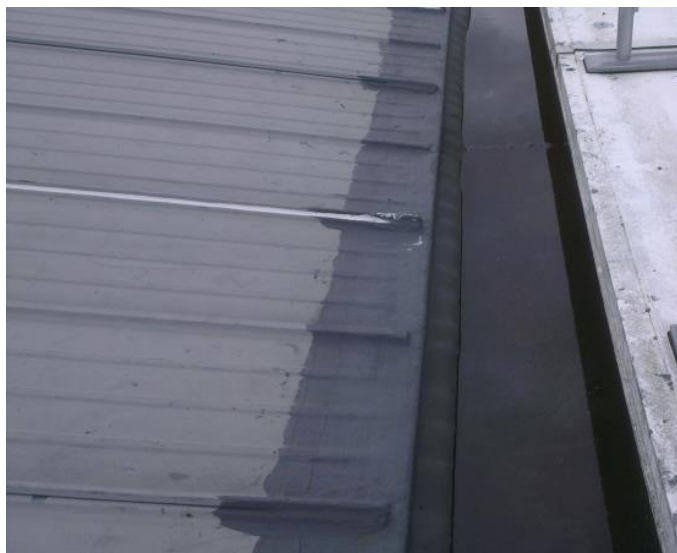
Fig 4 Water trapped below side slope of lining system extended onto roof sheets

Sometimes lining systems, either liquid-applied or membrane, are dressed up to the underside of, or even onto, the roof sheets to increase the effective gutter depth. This can be a dangerous method to adopt, as if there are any faults at all in the roof sheets, water will flow down the liner tray, build up in the void between the new liner and the existing gutter liner, and thus leak into the building.
