REFURBISHMENT OF INTERNAL METAL GUTTERS

INTRODUCTION

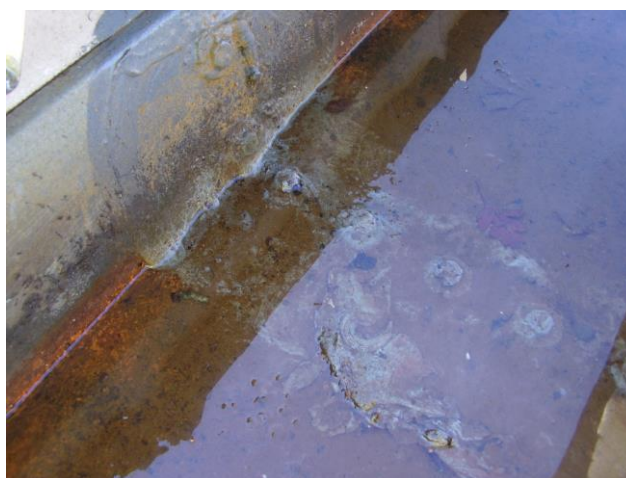
Fig 1 Metal gutter suffering corrosion and joint leakage

In most industrial buildings with internal gutters, those gutters are fabricated from galvanised steel with bolted joints. However, all building products have a life expectancy and in older installations, corrosion of the gutter steel substrate and leakage at the bolted gutter joints can occur.

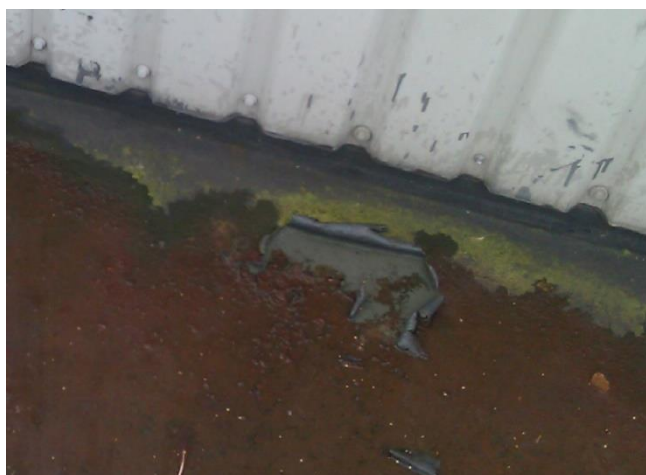
Fig 2 Liquid applied lining material delaminating from the gutter

The gutter has to be completely clean, grease and debris free, so that the compound can adhere well to the gutter. Great care must be taken when applying the material around bolt heads to avoid pin prick holes, through which water can leak. Badly applied sealant of this type can peel off after a fairly short period of time, leading to a renewal of leakage into the building. In most cases this is not considered a permanent repair.

A more sophisticated approach is to line the gutter with a liquid applied sealant together with a separate fibre reinforcement mat. Usually this will involve multiple layers of reinforcement and sealant, and will often be applied as a total lining rather than locally across joints. This approach can be very successful, though again it must be noted that preparation, workmanship, and weather conditions during installation can have a significant impact on the effectiveness of the final product. Care must be taken to ensure that the surfaces are clean and dry before the lining takes place, and that outlets are protected against sealant running into them and fouling the rainwater pipes.

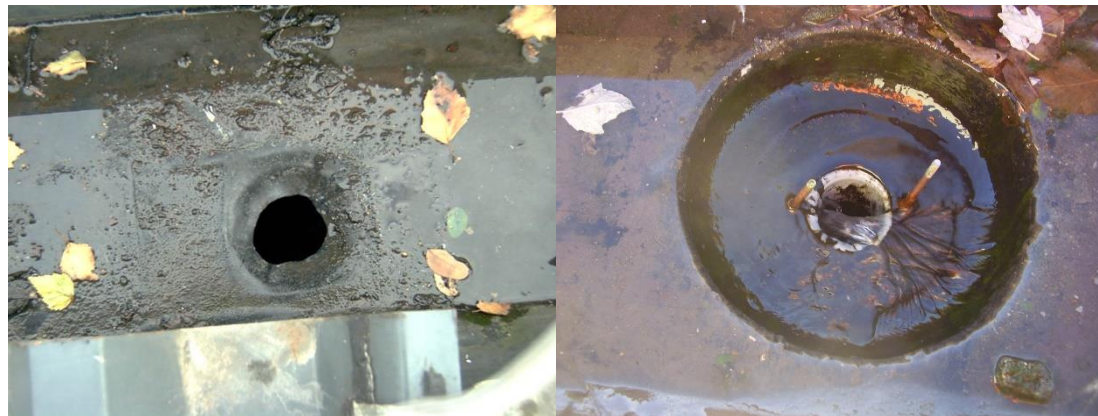
Fig 3 Gravity (left) and siphonic (right) outlets restricted by installed liners

Installing sleeve outlets in any lining system reduces the capacity of the system, as the new outlets will be smaller. This may lead to a situation where day to day leaks are prevented at the expense of significant overflows in heavy rain. Gutters must be checked to ensure that their design capacity after the installation of the liner is adequate; if not, additional outlets may have to be added to achieve this. It is likely that the installer of the liner would be held liable for any flood damage which occurred after installation, so this needs to be checked.

One area where this is particularly important is where the building has siphonic outlets. Any liner which protrudes down into a siphonic outlet should not be used without taking advice from the original manufacturer of the siphonic system or an independent expert. Lining into siphonic outlets can reduce capacity by as much as 80 per cent which can have a disastrous effect of the ability of the roof to drain.

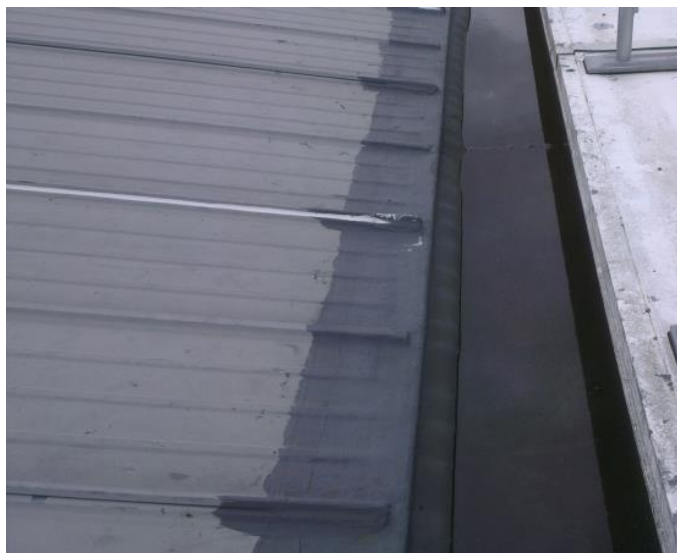
Fig 4 Water trapped below side slope of lining system extended onto roof sheets

Sometimes lining systems, either liquid-applied or membrane, are dressed up to the underside of, or even onto, the roof sheets to increase the effective gutter depth. This can be a dangerous method to adopt, as if there are any faults at all in the roof sheets, water will flow down the liner tray, build up in the void between the new liner and the existing gutter liner, and thus leak into the building.
