The Re-Sealing of Joints in Cast Iron Gutters

GUIDANCE DOCUMENT GD 11

June 2026

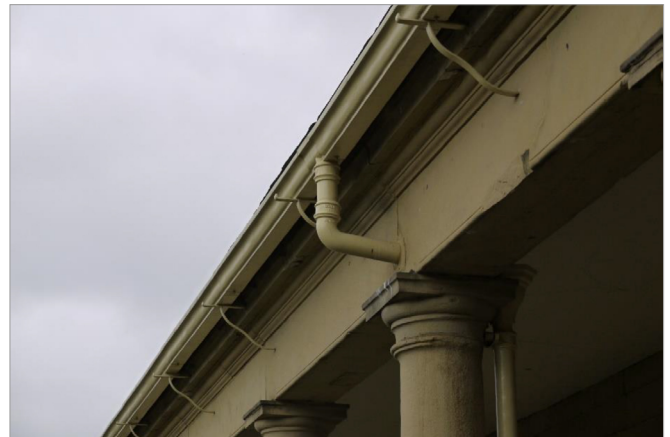
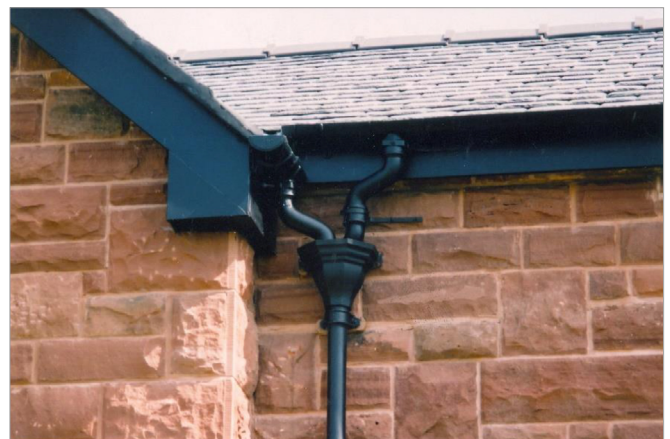
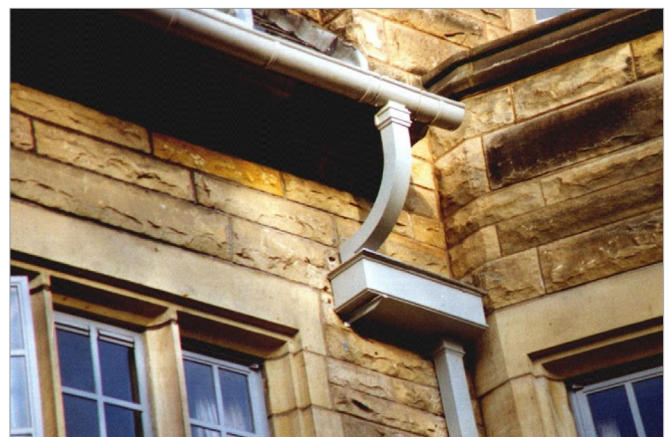
Typical examples of re-sealed joints

In summary, for leaking gutter joints it is strongly recommended to cut through the jointing bolts, thoroughly cleaning the gutter and reseal with a modern low modulus silicone sealant which will ensure many years of trouble-free life.
