Cast Iron Gutters and Rainwater Pipes Maintenance and Refurbishment

GUIDANCE DOCUMENT GD 12

The Re-Sealing of Joints in Cast Iron Gutters

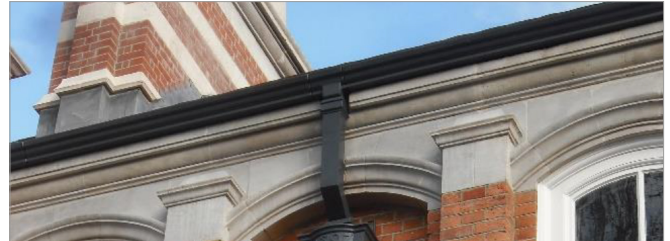
3. Rainwater pipes should be free of blockages, if a restriction is found, action should be taken immediately to remove any blockage before winter months set in to avoid the formation of ice which may cause the cracking of the pipe system in freezing conditions. This area can be identified by water cascading through the socket and running down the external surface of the pipe.
4. Inspect the condition of the paintwork whilst carrying out the annual inspection and wipe clean any film build up to protect the surface finish
5. Check on the security of fixings and joints.
6. Regularly inspect for signs of deterioration; any areas of corrosion damage should be repaired in accordance with the manufacturer's instructions.
